ASDE-2 TRANSMITTER MODIFICATIONS

Federal Aviation Administration

14
REPORT NO. FAA-RD-72-32

SEPTEMBER 1972
FINAL REPORT

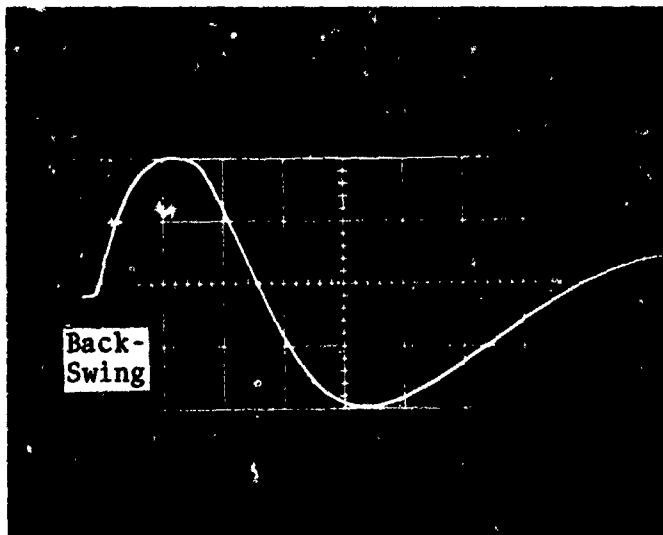
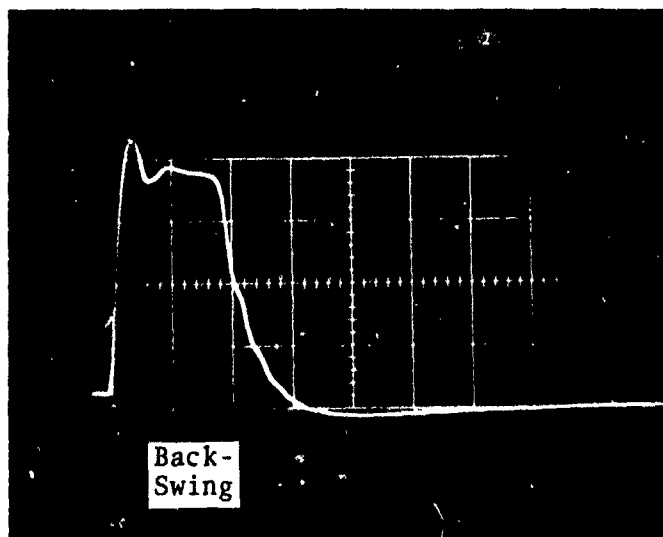
Figure 3. Comparison of Pulse Amplifier Outputs
with Thyatron Removed.

The old and new pulse amplifier outputs are shown in Figures 3 and 4. The two circuits compare as follows:

1. The old circuit could not trigger 3C45's reliably and could not trigger larger thyratrons at all.
2. The new amplifier will not only trigger larger thyratrons but will also fire used 3C45's without arcing. The same 3C45's could not be triggered by the old circuit without some of the tubes going into continuous conduction.
3. All of the component changes were made without chassis modifications, i.e. the new components fit the space occupied by the old parts. Thus, the modification can be made without drilling the chassis.

Note lack of pulse
shape and excessive
back swing

Present pulse
amplifier output,
6AQ5

Unloaded pulse has
very little back
swing

Modified pulse
amplifier output,
6DS5

Adequate pulse output for triggering the hydrogen thyratron was obtained by a related series of changes. First, the 6AQ5 circuit was changed from the original triode to a tetrode connection. This change increased the plate pulse to 250 volts. The plate impedance was reduced to 500 ohms by replacing the 6AQ5 with a 6DS5. Finally, a new pulse transformer with a ratio of 1 to 1.6 (originally, 1 to 3) was substituted for the original transformer, resulting in an unloaded pulse output of 400 volts with an internal impedance level of

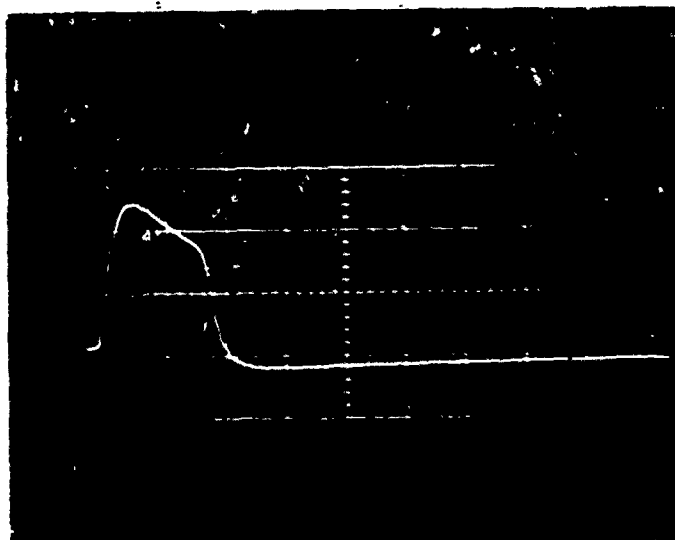
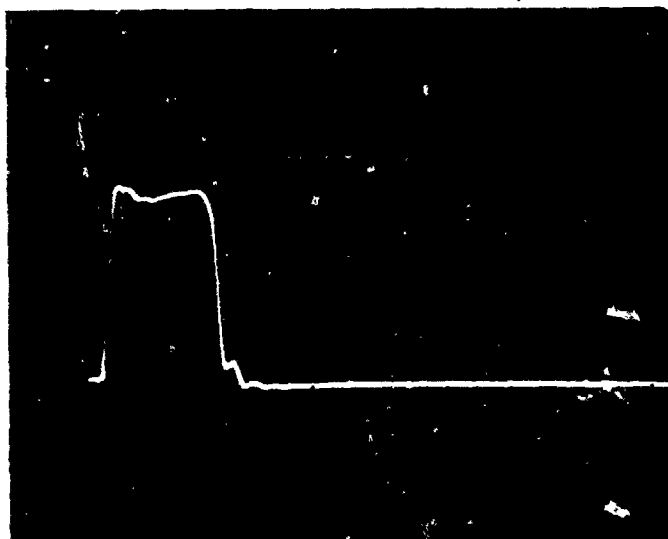
Figure 4. Comparison of Pulse Amplifier Outputs with a 1500 ohm Load.

The 125 volt pulse is inadequate for reliable thyatron triggering

Present pulse amplifier output, 6AQ5

Pulse output is ~ 300 volts which will provide excellent thyatron triggering

Modified pulse amplifier output, 6DS5

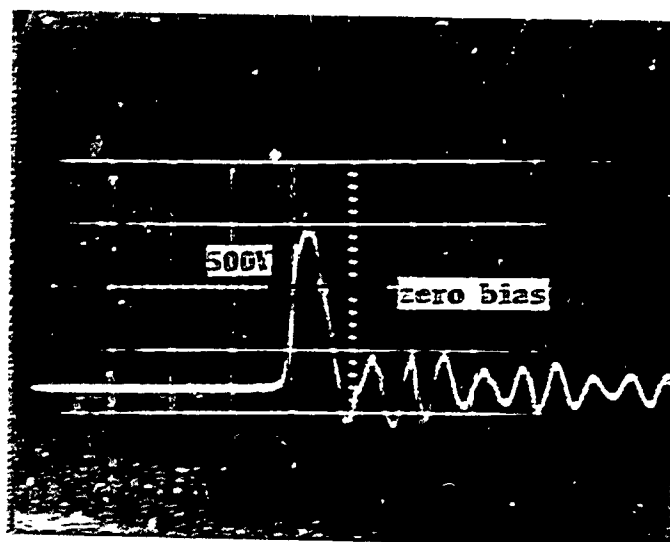
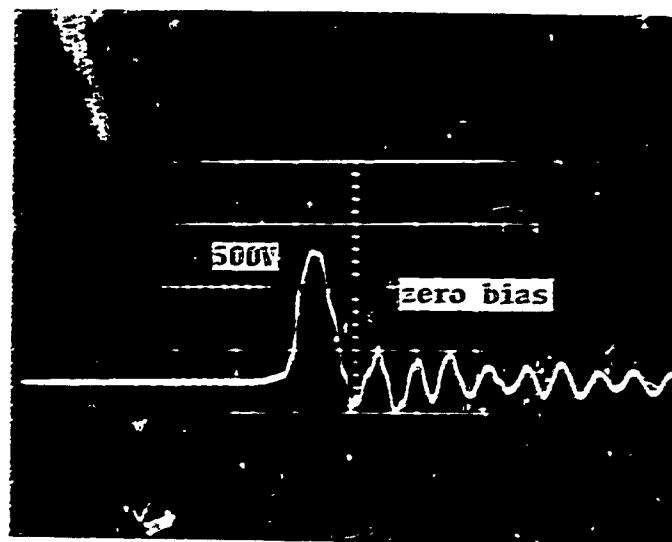
Figure 5. Pulse at Grids of 4PR60's

4PR60's grid pulse delivered by 8765 thyratron. The portion of the pulse above the center line is the amount of grid drive and is about 350 volts

The same pulse delivered by a 3C45 thyratron. The grid drive is less than 300 volts

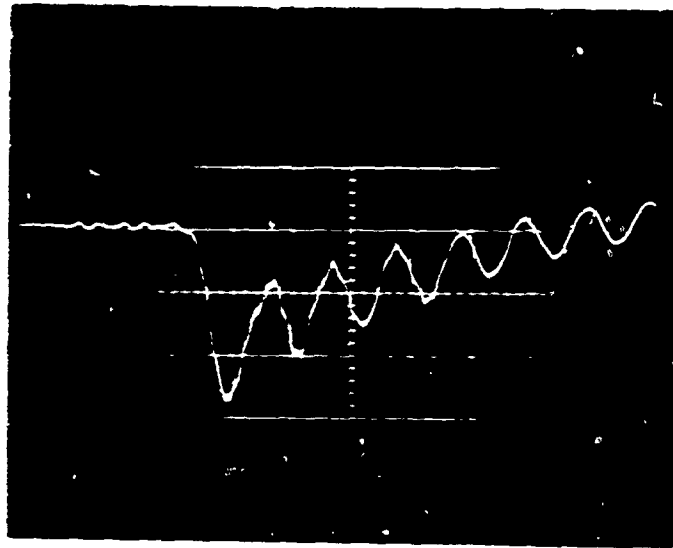
Figure 6. Magnetron Voltage Pulse

The pulse was taken with the original coupling capacitor. Its value is 1000pF, and it has a series inductance of 2.0 μ H.

or 63 nanoseconds which agrees quite well with the time shown in Figure 6. Some or all of this problem could be eliminated by increasing the ringing time and the circuit damping. However, this could increase the "bleed" current from 6 to 24 amperes, and is really not a practical solution. For these reasons, other methods of preventing double pulsing were tried.

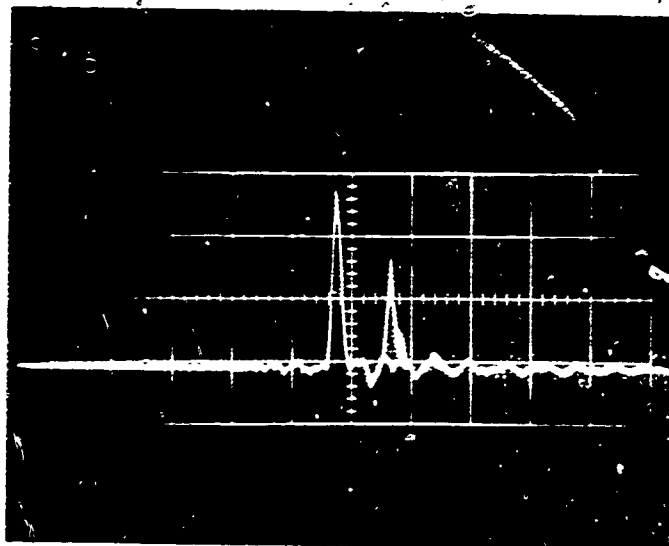
Figure 8. Magnetron Double Pulsing

This long time constant can be a serious problem for at least two reasons.⁴ First, the magnetron may not turn off cleanly and the pulse spectrum may contain noise and cause interference with nearby targets. Secondly, the coupling capacitor may contain series inductance and result in transient oscillations of the magnetron voltage pulse during the re-charge portion of the cycle. While the spectrum noise does not appear to be serious, the ringing due to inductance is a potential problem with some magnetrons. Figure 6 shows this ringing clearly. The first crest after the main pulse may cause the magnetron to oscillate as shown in Figure 8, which should be compared to the single RF pulse shown in Figure 7.

Magnetron RF pulse (rectified) sample shows how double pulsing can occur when the magnetron voltage pulse shape is improper.

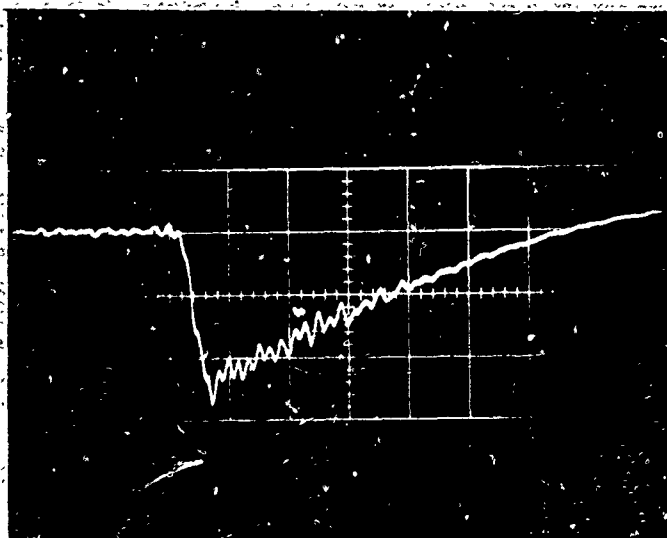
Figure 10. Magnetron Voltage Pulse with a Very Low Inductance Capacitor

A low inductance capacitor (0.2 μ H) was installed with mixed results. The ringing frequency was increased accordingly and the double pulsing was reduced but not completely eliminated. Figure 10 shows the magnetron voltage pulse with a 2000pF, low-inductance capacitor. Double pulsing was produced simply by adjusting the magnetron voltage. Figure 11 shows the magnetron voltage pulse with a 5000pF, 32 μ H capacitor. Strangely enough, double pulsing could not be produced even though the second pulse is quite pronounced. This is due to the fact that the height of the second pulse is not sufficient to turn the magnetron on.

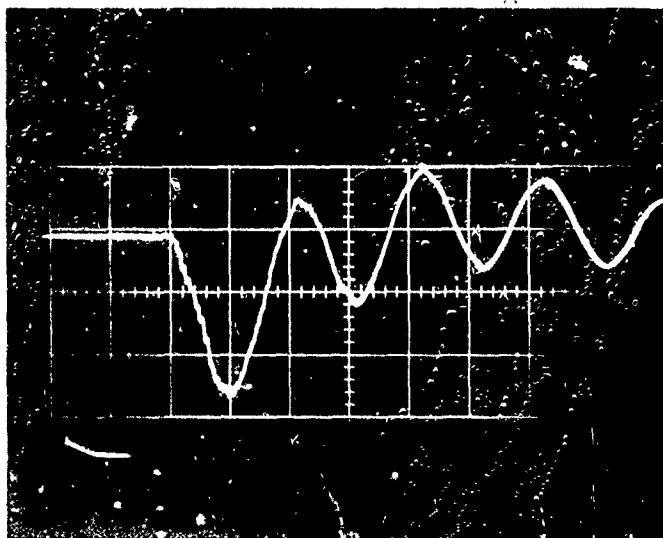
Figure 11. Magnetron Voltage Pulse with a Very High Inductance Capacitor.

A high inductance capacitor would increase the ringing period and reduce the tendency to double pulse. However, the modulator high voltage would have to be increased considerably to produce any magnetron oscillations, again not a very practical solution. Alternatively one could use a high capacity, low inductance capacitor and add an external series inductance to increase the width of the main pulse and depress the first ringing crest below the required firing voltage. The results of such a change are shown in Figure 12. The value of series inductance was chosen empirically. The optimum value turned out to be 1.7 μ H for the following reasons:

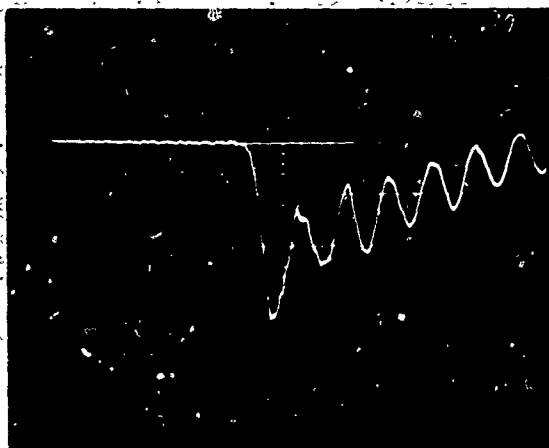
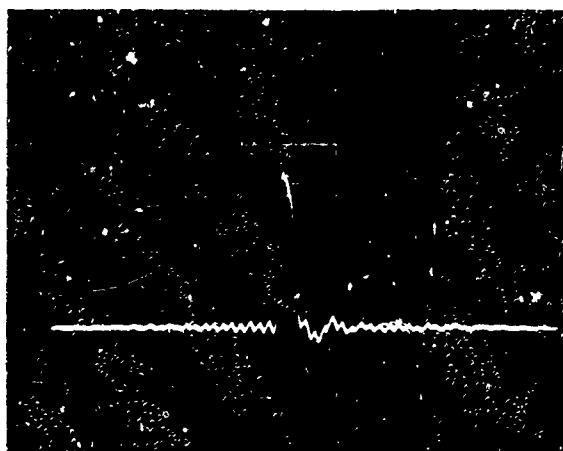
Figure 12. Magnetron Pulses with a Low Inductance 2000pF Capacitor and a 1.7 μH Inductor in Series.

1. The modulator dc voltage could be reduced without reducing the average magnetron current.
2. The main pulse is more than 20ns wide, producing an RF pulse somewhat broader than the 16ns previously observed.
3. Double pulsing could in no way be produced, even with the magnetron that was so easily double pulsed before.
